Hazardous Materials
Assessment Report –
Crawford Generating Station

October 2012

Crawford Generating Station 3501 South Pulaski Road Chicago, Illinois

Asbestos Survey Midwest Generation

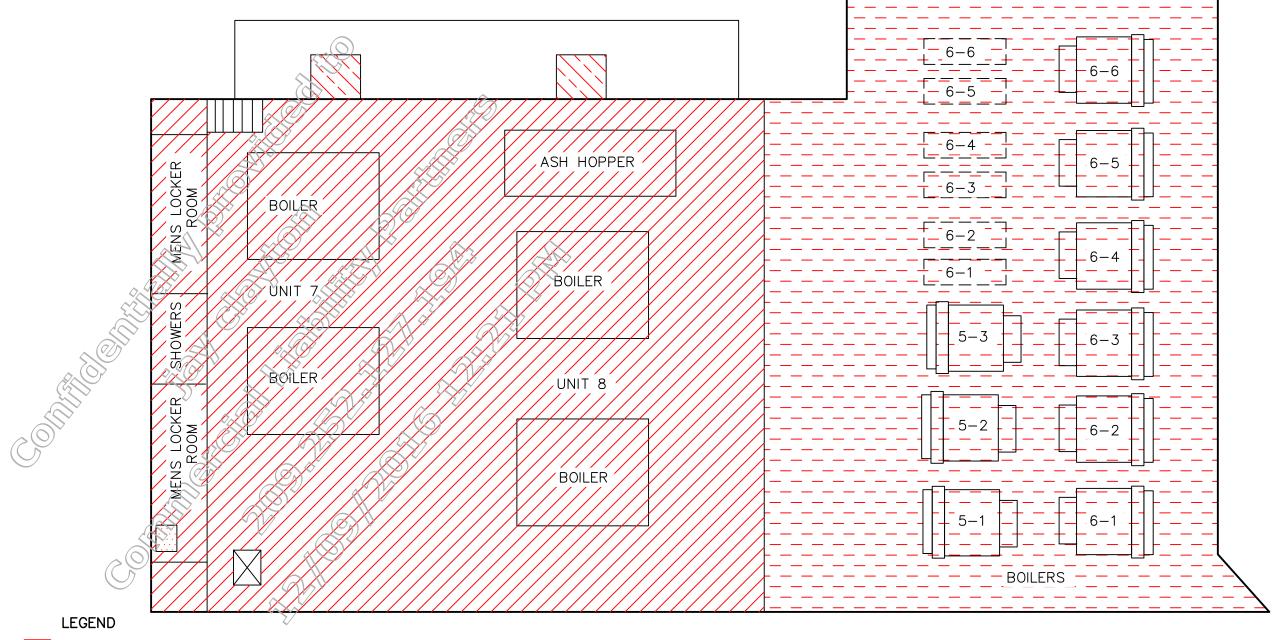
CONFIRMED ASBESTOS LOCATION MAP BOILER HOUSE - LEVEL 2 (41')

7/8 BOILERS AND THERMAL SYSTEM INSULATION

5/6 BOILERS AND THERMAL SYSTEM INSULATION (MATERIAL 45)
